Pilgrim Creek Restoration Project: Bird Community and Vegetation Structure

2004 Annual Report

By Barbara E. Kus, Jeannie Guzis, and Mike Wellik

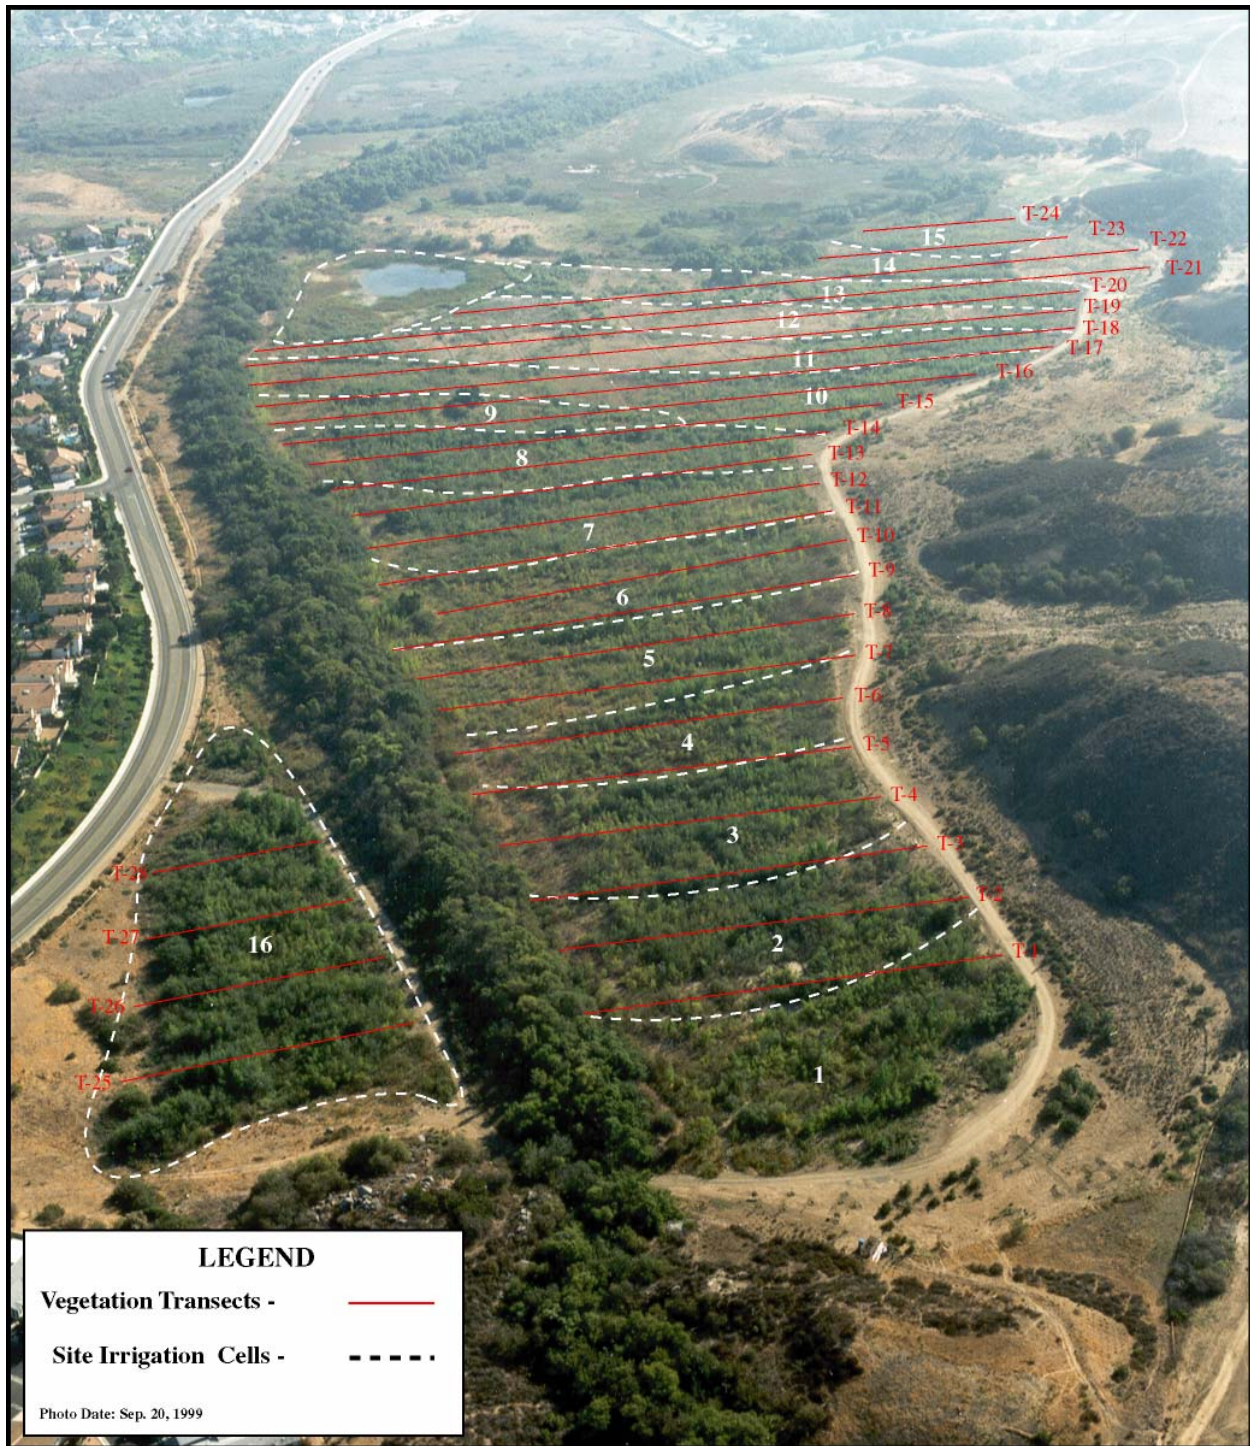
Figure 1. Vegetation transects and irrigation cells, Pilgrim Creek restoration site.

Vegetation data were collected at points along permanently marked transects running perpendicular to Pilgrim Creek and arrayed to provide uniform coverage of the restoration site (Figure 1). Twenty-four transects were established in 1997 in habitat to the west of the river, and measured annually. An additional four transects were established in the restored habitat east of the creek in 1998 and measured annually thereafter. A total of 506 quads spaced at 10-m intervals along the transects were measured, yielding a sampling density of 30 quads per hectare (12 per acre). Foliage volume at 1-m height intervals was estimated using the "stacked cube" method, developed specifically to characterize canopy architecture in structurally diverse riparian habitat. By this method, field workers record percent cover of vegetation, by species, within 2- by 2- by 1-m high sampling volumes "stacked" vertically between the ground and the top of the canopy above the point. Four 2-m lengths of PVC pipe are placed on the ground to define the quadrat boundaries, and connectible lengths of PVC, marked at 1-m intervals, are used to determine height within the canopy. Percent cover is scored in the field using a modified Daubenmire (1959) scale with cover classes < 1, 1-10, 11-25, 26-50, 51-75, 76-90, and >90 percent. For analysis, cover codes were converted to class midpoints, which were then used to quantify vegetation structure at each sampling point, within each planting cell, and for the site as a whole.

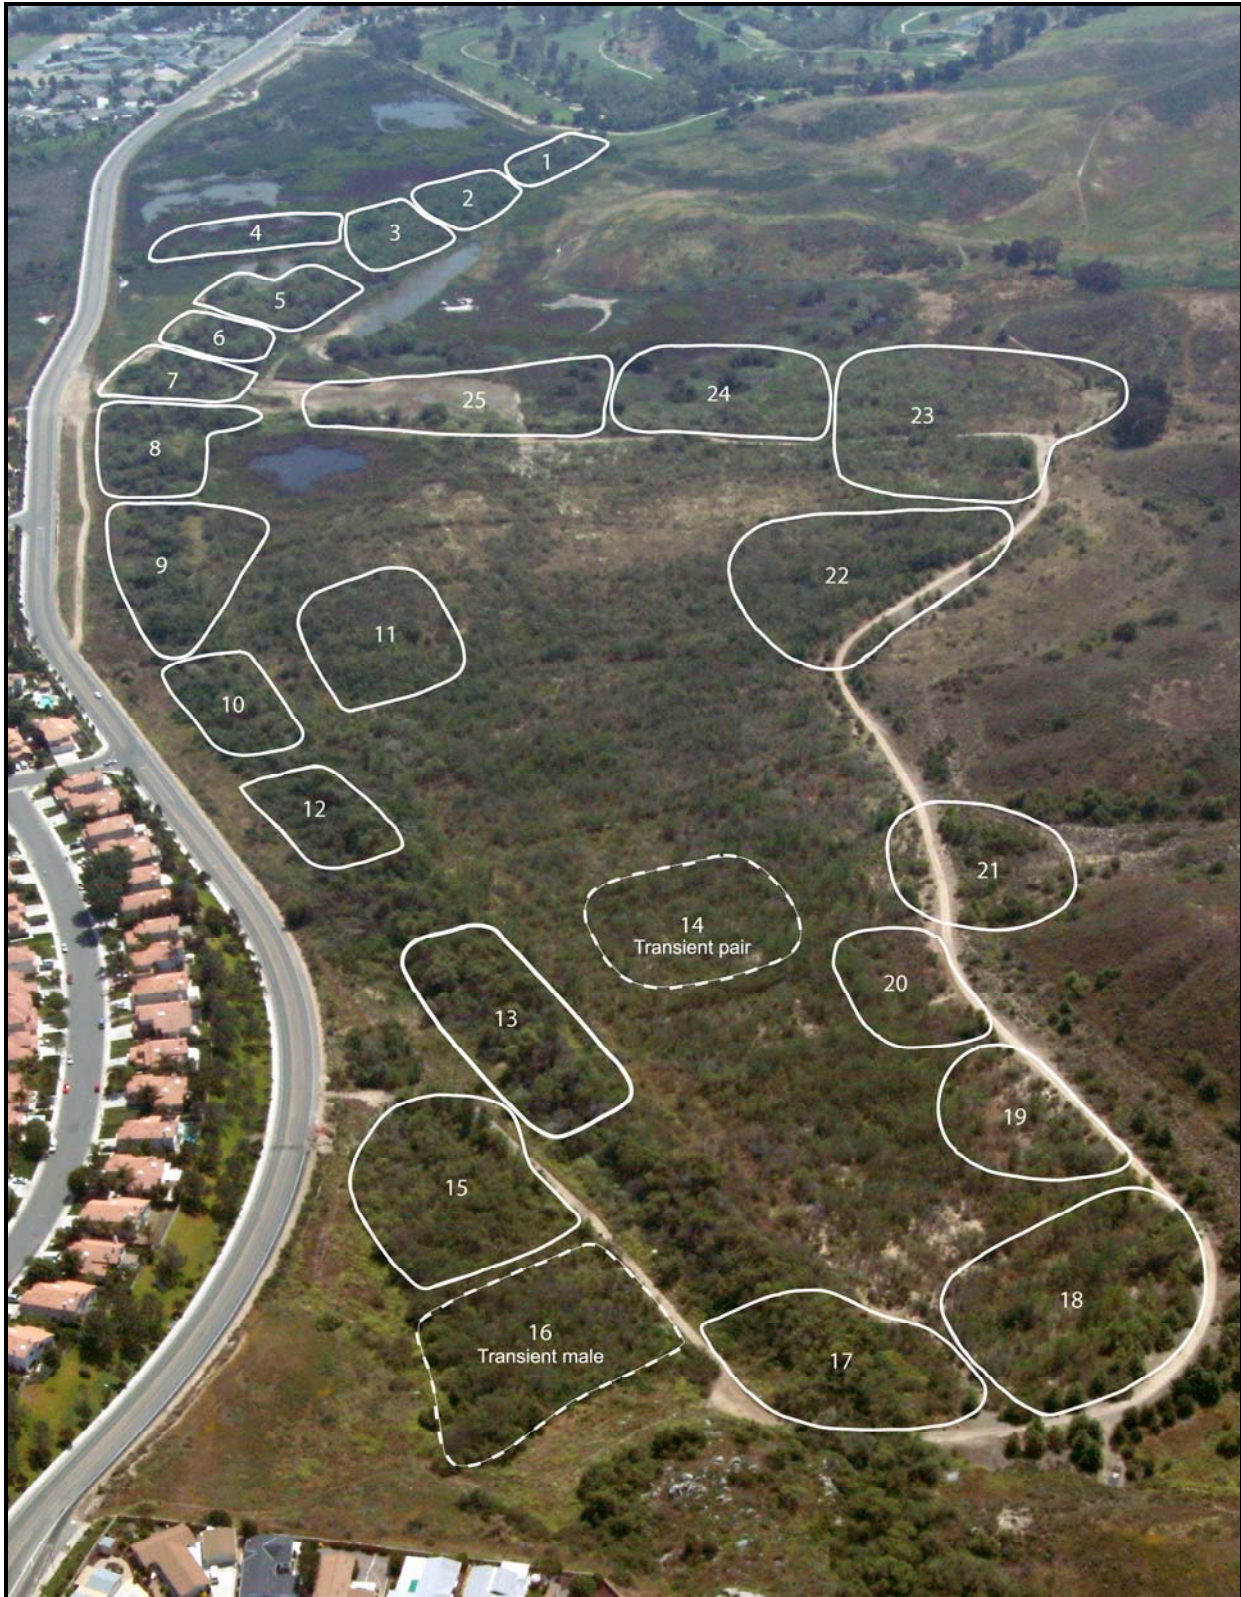
Figure 2. Least Bell's Vireo Territory Locations at Pilgrim Creek, 2004.

The Least Bell's vireo population within the study site numbered 23 territorial males in 2004, all of which were paired (Figure 2, Table 1). In addition, one transient pair was observed on 12 May in area 14 (Figure 2) but not seen again, and one transient male was observed early in the season in area 16 (Figure 2); this male may have eventually settled in Territory 17 (Figure 2). The overall population increased by 10% from 2003, when 21 territories were present (Kus *et al.* 2004), while the breeding population (number of pairs) increased by 15% from 20 pairs present in 2003. All of the 23 pairs were monitored for nesting activity in 2004.

Eleven territories were established within the restored riparian habitat (Figure 2), identical to the number in restored habitat in 2003 (Kus *et al.* 2004). In addition, Transient 16 occupied habitat in Cell 16 early in the season, and Transient Pair 14 was observed in Cell 5. Eight of the 11 territories were situated entirely within restored vegetation (Territories 11, 15, 18, 19, 20, 21, 22 and 23), while three territories (9, 17, and 25) were made up of 50% or less planted vegetation and the rest mature woodland. Vireos occupied sites used in previous years and expanded their use of the restored habitat to include the areas with Territories 19 and 20 (Figure 2). All of the territories in restored habitat were occupied by nesting pairs. A total of 12 completed nests were located in restored vegetation, of which five (42%) fledged young; four nests were placed in mature habitat, of which one (25%) was successful.

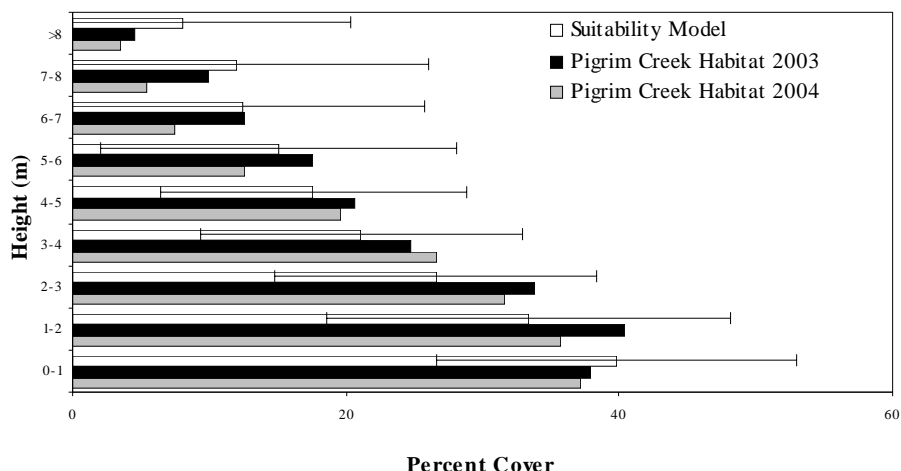
Figure 3. Average percent cover by height: Pilgrim Creek, 2003-2004.

Foliage cover in the reference habitat along Pilgrim Creek was comparable to cover in 2003 (Kus et al. 2004) at heights up to 5 m with the exception of cover at 1-2 m, which declined slightly (Figure 3). Cover at heights above 5 m declined to approximately 60-70% of the cover measured in 2003. In contrast, cover in the restored habitat was comparable to that in 2003 or declined only slightly at heights above 2 m, and was approximately 80% of the cover measured below 2 m in 2003 (Figure 4). Nevertheless, the restored habitat continued to meet the habitat suitability model's criteria at all heights.

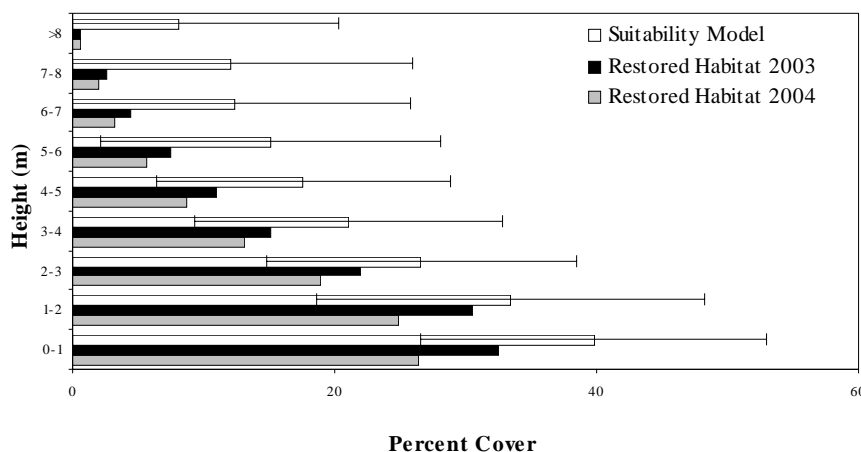
Figure 4. Average percent cover by height: restored habitat, 2003-2004.

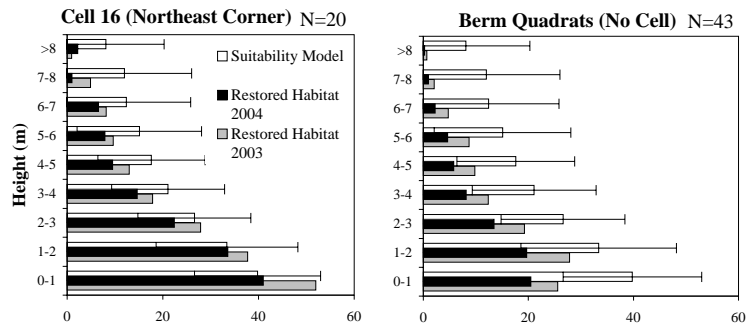
Figure 5. Average percent cover by height of restored habitat: cell-by-cell assessment, 2003-2004

Figure 5 (cont.). Average percent cover by height of restored habitat: cell-by-cell assessment, 2003-2004.

Canopy cover in cells situated in the northern section of the restoration site (Cells 1-6) increased or was comparable to that in 2003 (Kus et al. 2004), while cover in the rest of the site (Cells 7-15) declined slightly (Figure 5). Declines in cover occurred primarily at heights below 2 m, probably a reflection of annual differences in herbaceous cover at the site. Despite these declines, nine of the 16 cells (56%; Cells 1-5, 7, 8, 10, and 16) met the criteria of the habitat suitability model at all heights, and an additional three cells (Cells 6, 9, and 11) met the criteria at nearly all heights. Cover in the remaining cells (Cells 12-15), in the southern section of the restoration site, continues to progress more slowly in development of the canopy height and density typical of vireo habitat.

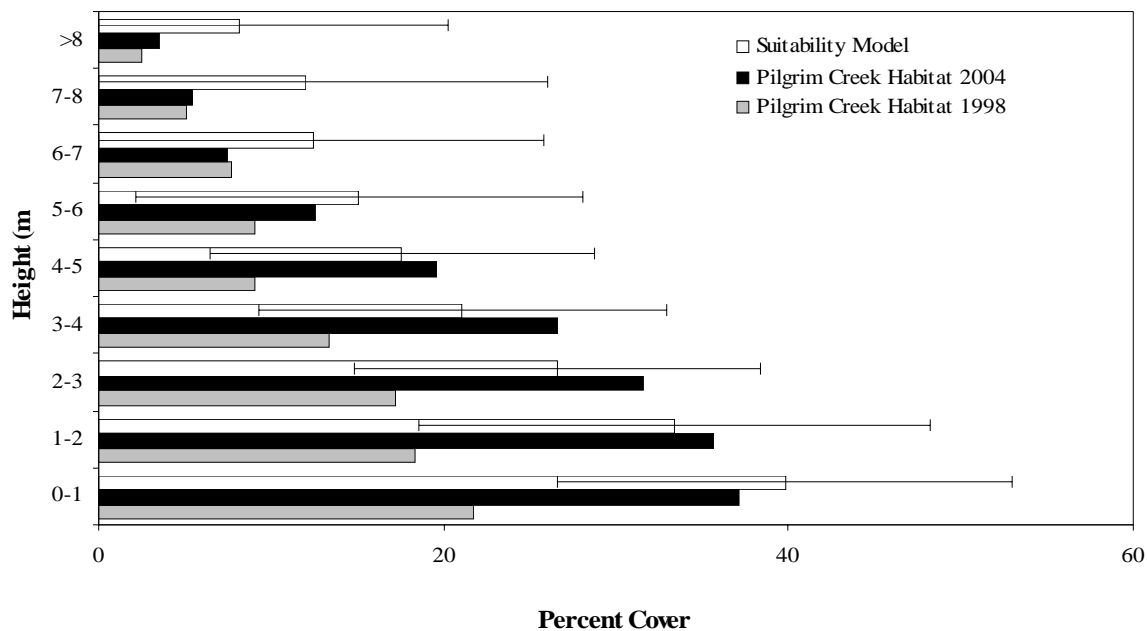
Figure 6. Average percent cover by height: Pilgrim Creek, 1998-2004.

Vegetation cover at Pilgrim Creek generally changed only slightly between sequential years, but nearly doubled at heights below 5 m over the course of the study (Figure 6). The factors responsible for the increase in vegetative cover are unknown, but may be related to changed hydrology or the discontinuation of practices associated with the previous agricultural use of adjacent lands. In any case, riparian habitat along the creek has not been static, and annual measurement of vegetation structure has provided a current reference with which to compare vegetation development at the restoration site.

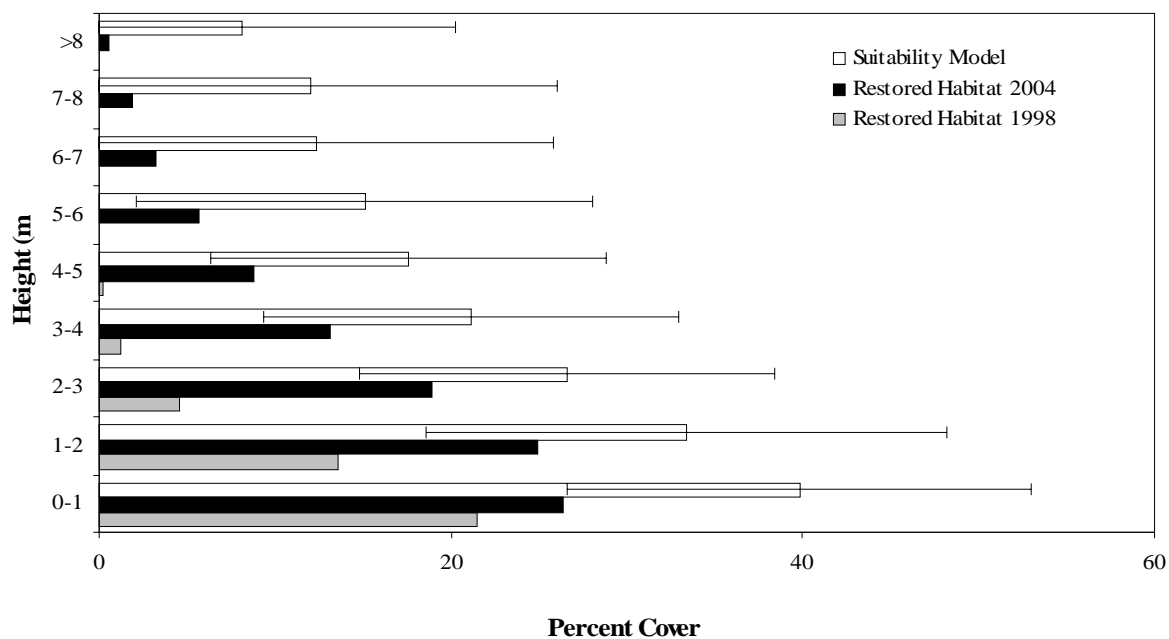
Figure 7. Average percent cover by height: restored habitat, 1998-2004.

Overall, the restored vegetation changed dramatically between 1998, when vegetation sampling commenced, and 2004 (Figure 7). Canopy height increased from 4 m at the beginning of the study to greater than 8 m by the end, achieving the vertical profile of the reference habitat. Foliage cover increased throughout the canopy and by 2003 met the criteria of the habitat suitability model at all heights. These changes in canopy height and cover were evident in virtually every cell (Figure 8) despite variability among cells in their suitability as vireo habitat.

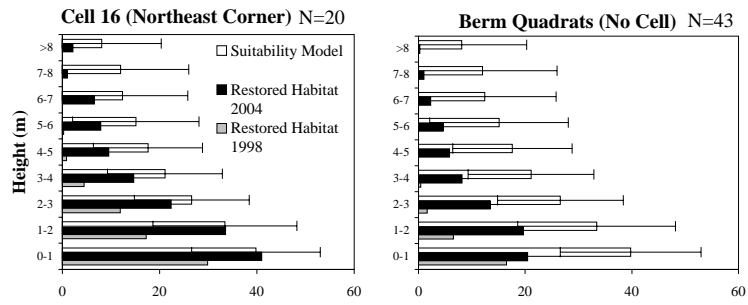
Figure 8. Average percent cover by height of restored habitat: cell-by-cell assessment, 1998-2004

Figure 5 (cont.). Average percent cover by height of restored habitat: cell-by-cell assessment, 1998-2004.
